Intel[®] Mobile Celeron[™] Processor at 466 MHz, 433 MHz, 400 MHz, 366 MHz, 333 MHz, 300 MHz, and 266 MHz Specification Update

Release Date: September 2000

Order Number: 244444-018

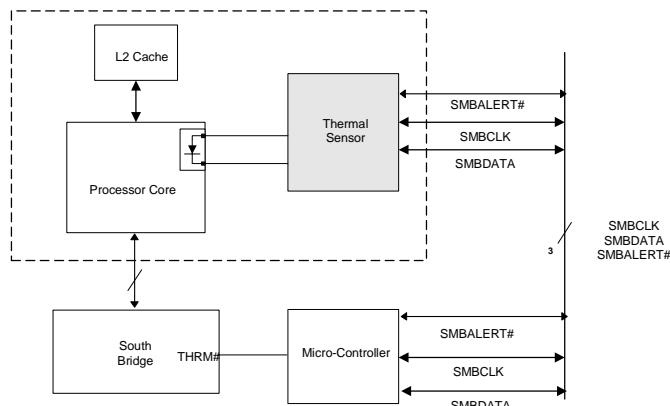
Figure 1. An Example of Microcontroller Driven Thermal Management

H29. Thermal Sensor May Assert SMBALERT# Incorrectly

Problem: The Intel Celeron Processor Mobile Module has a thermal sensor that monitors the processor core's temperature. Please note that desktop systems could have a similar thermal device. The thermal sensor asserts SMBALERT# if the processor temperature exceeds the temperature limits set in the Alarm Threshold Registers (T_{HIGH} , T_{LOW}). It also sets the corresponding Status Register bits to identify the cause of the interrupt. Figure 1 gives one example of the how the SMBALERT# signal could be used in a system.

Implication: There is no system impact from this erratum if temperature polling is used for processor thermal management. If the SMBALERT# interrupt is employed to manage processor thermal sensing, then servicing the false interrupt may result in premature system action depending on the software and hardware implementations used. The rate of the false interrupts is less than the auto-convert rate of the thermal sensor.

Workaround: Three different (mutually exclusive) workarounds are possible:

1. Before servicing an interrupt from the thermal sensor, read and compare the processor thermal reading with the threshold limits (T_{HIGH} or T_{LOW}). Figures 2 and 3 provide basic flowcharts for the implementation of this workaround in an interrupt driven system.
2. If the firmware implemented polls the Status Register only, then before taking any action, re-read the temperature register and do a comparison with the alarm threshold limits (T_{HIGH} or T_{LOW}) to determine if the value is actually still within the temperature window.
3. Use a temperature polling scheme to monitor the processor temperature.

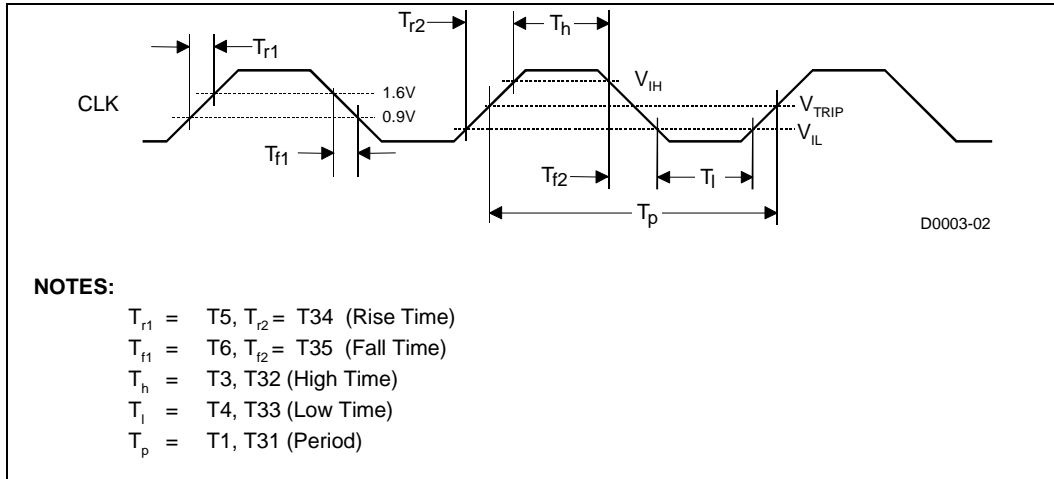
Figure 3.3 Generic Clock Waveform

H11. Generic Clock Waveform Figure

Figure 3.3 in the *Intel® Mobile Celeron™ Processor in μPGA1 and BGA1 Packages at 366 MHz, 333 MHz, 300 MHz, and 266 MHz* datasheet (Order Number 245112-003) has been updated. The following figure is to replace the one in the above document.
